Home Inspection Report

5678 Lemon Street
Mount Prospect, IL
60056

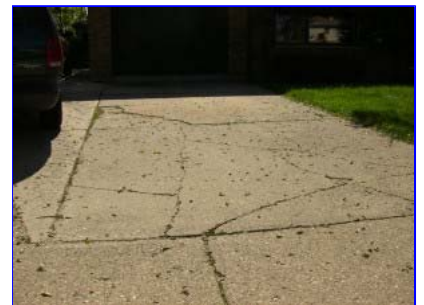
Driveway

-There are large cracks in the driveway.

There are some large cracks that are consistent with the age of the property, but they do not affect the functionality of the driveway. These cracks should be monitored.

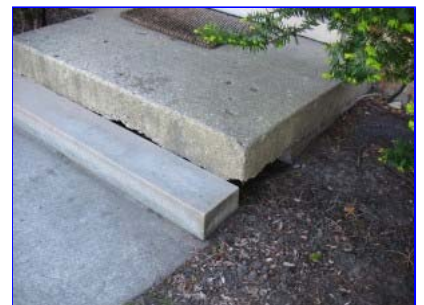
Steps To Building

The stoop has settled near the house creating reverse drainage. We recommend railings on landing & stairs for safety. The area is not properly flashed or caulked. There is evidence of poor drainage. Cracks in concrete or mortar are in need of repair.

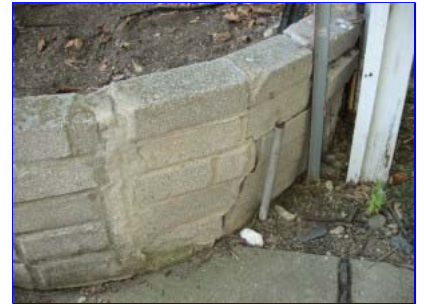
-The retaining wall shows signs of deterioration.

The retaining wall at the back of the home has been damaged. The retaining wall is deteriorating. Cracks in the retaining wall could lead to further cracking and erosion.

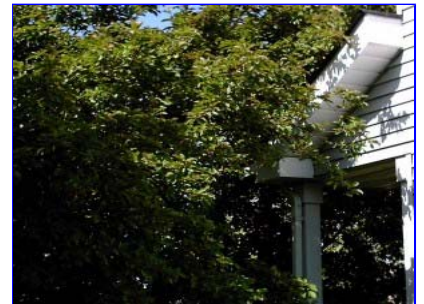
-There are shrubs growing too close to the foundation.

Keep tree branches trimmed away from the roof. Keep tree branches trimmed away from the siding. Shrubbbery is contacting structure. Keep shrubs trimmed away from the siding. We suggest that broken tree limbs be removed.

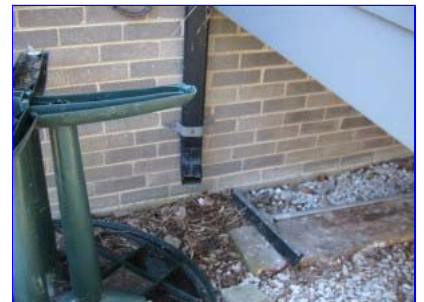
Grading At House Wall

-The ground slopes toward the house creating a flooding hazard.

Slope of grade away from structure is inadequate. The grade slopes toward structure. Add fill near the house to slope away approximately 1" per ft. within 6 ft. Keep downspouts extended 5-6 ft. from the house.

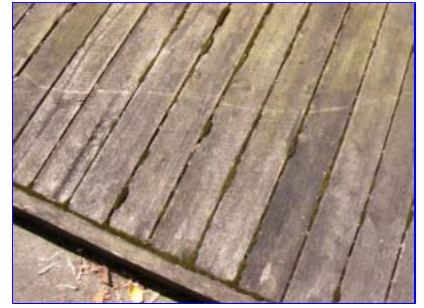
Deck/Porch

- There is evidence of deterioration where the deck comes in contact with the ground.
- There is evidence of rot on the surfaces of untreated wood.
- There is cracking/deterioration on the deck floor or railings.
- There is separation or sagging due to deterioration.
- There is flashing missing between the deck and the house.

Deck has deteriorated severely due to poor drainage which has caused water damage. Rail system is not securely attached. You should consult a licensed contractor about the needed repairs.

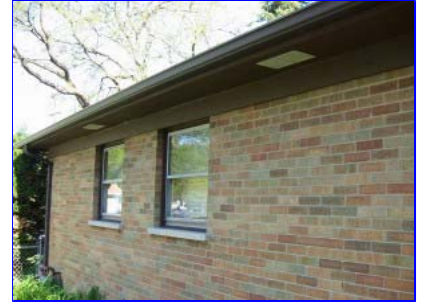
Recommend adding weep holes to the bottom course of bricks to allow possible trapped water to drain out from wall cavity.

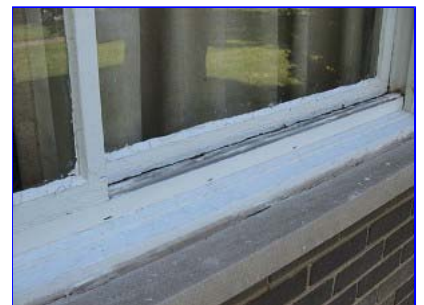
-There are gaps or openings around the window(s) that need to be caulked.
-There are cracked, broken, or missing windows.

This component is in need of minor repair. Windows are not properly caulked. Over time all caulking compounds will deteriorate and require maintenance.

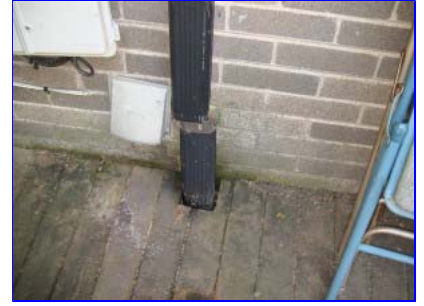
- The downspouts cause water to pool and run toward the house.
- There are spots where downspouts are missing resulting in deterioration to the house.
- There are downspouts missing from the building.

Downspout does not divert water away from foundation properly. There are downspouts that need to be extended. Keep downspouts extended 5' - 6' from the building. Gutters and downspouts need to be added.

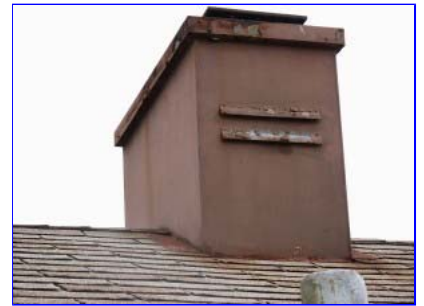
Rusting was observed on chimney cap. Chimney flashing is improperly installed. You should consult a licensed contractor about the needed repairs.

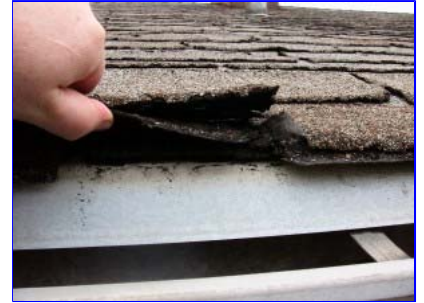
- There are gaps between the shingles.
 - There are more than 2 layers of shingles.
 - The shingle tabs are clawing or curling up at the edges.
 - The shingle tabs are loose and can be lifted.
 - The shingles are brittle.
 - There are sagging, uneven, or damaged sections of roof covering.
-

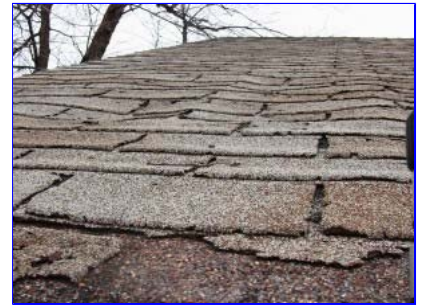
Roof Leaks

- The roof has weather-worn flashing.
- There is discoloration, rot, mold, or mildew on the roof framing.

There are some sunken areas where it is apparent that the shingles have failed and water is penetrating onto the sheathing. In such cases some of the sheathing may need to be replaced when the shingles are replaced. Further water damage could be occurring within the walls or ceilings as the result of water intrusion.

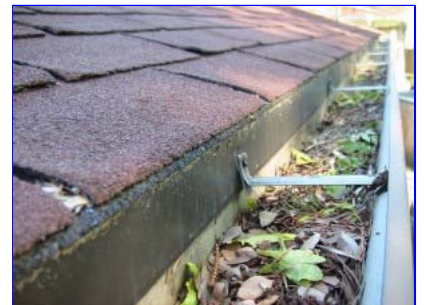
Gutters & Downspouts

- The gutters are clogged with debris from overhanging trees.
- The gutter/downspout connections are bad.
- There are missing sections of gutters/downspouts.

There are down spouts that need to be extended. Downspout does not divert water away from foundation properly. Damage or failure was observed.

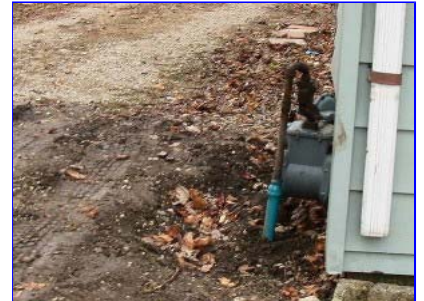
This gas meter is located between the driveway and a path where vehicles can be driven or parked which presents a safety hazard. Recommend protecting this location against any impacts.

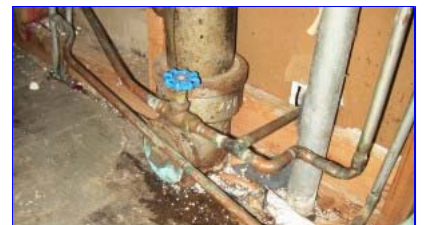
Cast iron part of system appears to have a small amount of seepage at the

joint as shown in the photo. Old cast iron pipes rust from the inside out and will eventually need to be replaced.

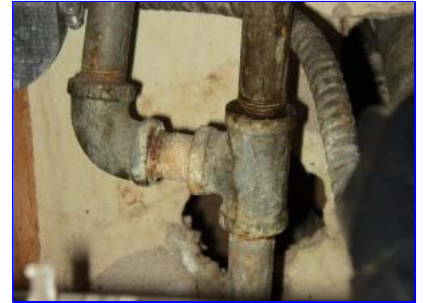
Fixtures

-There is corrosion on the pipes or valves.

The pipes beneath the bathroom and kitchen sinks are galvanized steel. Corrosion and indications of slow leaks were detected. Galvanized steel rusts from the inside out which can inhibit water pressure. Suggest budgeting for upgraded plumbing.

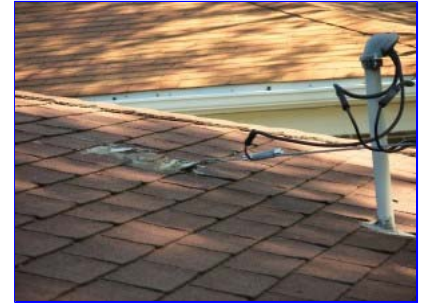
Service Entrance Cable

-The service entrance cable is improperly anchored to the wall.

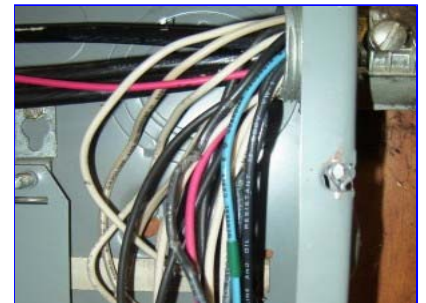
Main Panel

-There is evidence of circuit breakers failing / overloading.

One of the wires shown in the photo has melted insulation which could indicate an over-fused circuit. This could represent a fire hazard and should be examined by an licensed electrician.

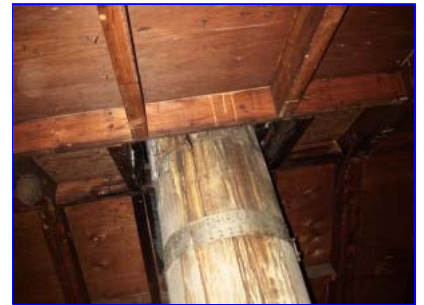
-There are vents that leak or function improperly.

As the photo shows, there are some leaks at flashing points where an exhaust flue goes through the roof. The stains on the flue are indications of this leak.

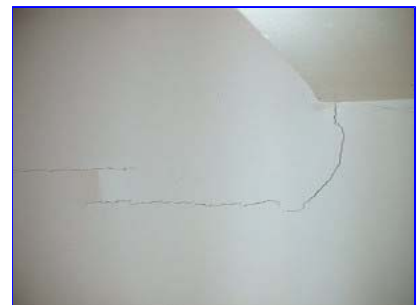
- There are cracks/holes in the wall.

The photo illustrates a crack in the kitchen wall near the ceiling which could indicate uneven settlement in one area of the house.

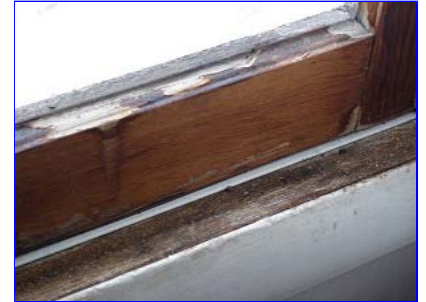
Some window sashes do not operate properly. Window weather stripping is damaged or defective. Fire egress for the window is inadequate in NE bedroom.

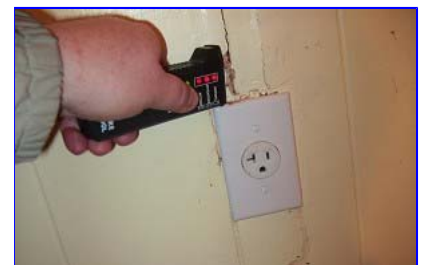
Photo shows the wall next to 240-volt outlet testing high for moisture. It appears that a roof leak is draining down the wall in the laundry room.

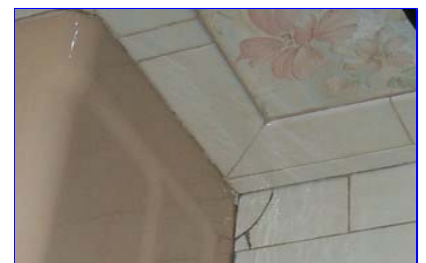
Tile is cracked near tub and needs re-grouted. Flexible caulking needs applied wherever tile meets an edge.

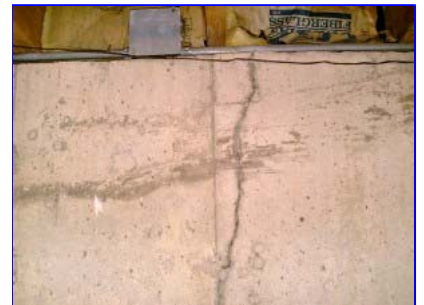
Foundation

Not all areas of the foundation were visible at the time of the inspection. The foundation appears to be performing from what can be observed. There are several thin cracks visible in the foundation less than a quarter inch wide which are typical of an older masonry foundation.

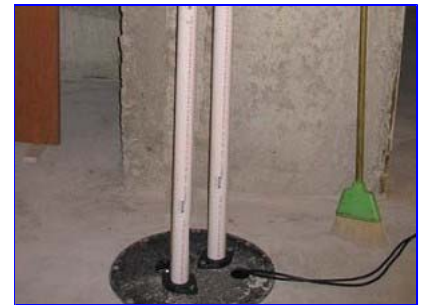
The sewage ejector pump was unplugged and may not function properly. The sewage ejector pump moves waste from basement plumbing fixtures (i.e. toilets, showers, etc) to the level of the sewer line

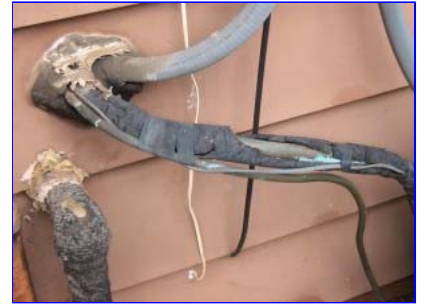
Air Conditioning Unit

- There are obstructions blocking a free air exchange.
- The refrigerant tubes are poorly insulated.

Model GE LMB-48AK10 (4-tons). The unit appears the right size for a 2,000 sq. ft. home and produces cold air when tested. The insulation on the return line is missing, damaged, or defective decreasing efficiency. Clean leaves and debris away from outdoor condenser coil.
