Home Inspection Report

5678 Lemon Street
Mount Prospect, IL
60056

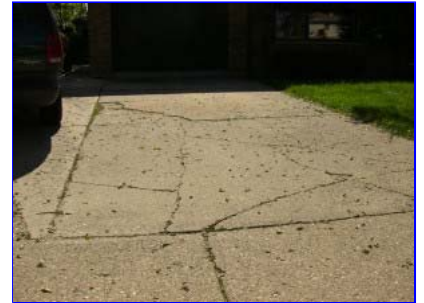
-There are large cracks in the driveway.

There are some large cracks that are consistent with the age of the property, but they do not affect the functionality of the driveway. These cracks should be monitored.

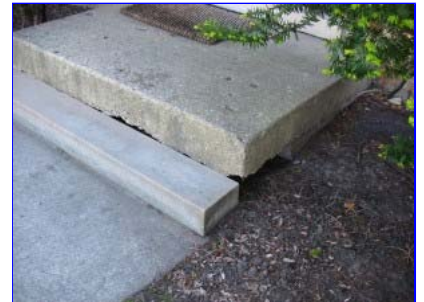
Steps To Building

The stoop has settled near the house creating reverse drainage. We recommend railings on landing & stairs for safety. The area is not properly flashed or caulked. There is evidence of poor drainage. Cracks in concrete or mortar are in need of repair.

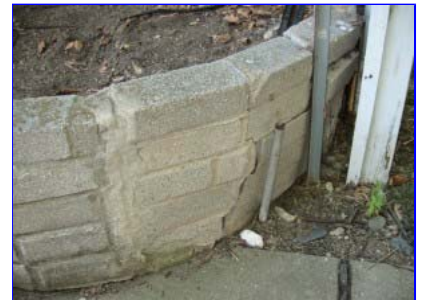
-The retaining wall shows signs of deterioration.

The retaining wall at the back of the home has been damaged. The retaining wall is deteriorating. Cracks in the retaining wall could lead to further cracking and erosion.

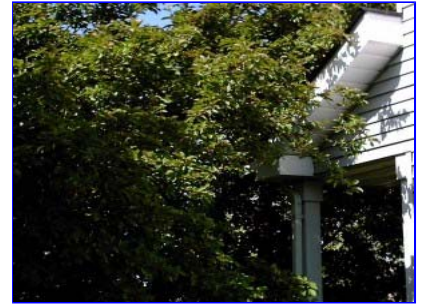
- There are trees growing within 6 feet of the house.
- There are tree branches rubbing against the house.
- There are trees growing too close to power lines.
- There are shrubs growing too close to the foundation.

Keep tree branches trimmed away from the roof. Keep tree branches trimmed away from the siding. Shrubbery is contacting structure. Keep shrubs trimmed away from the siding. We suggest that broken tree limbs be removed.

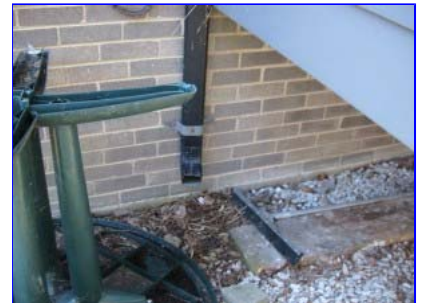
Grading At House Wall

- The ground slopes toward the house creating a flooding hazard.
- There are low-lying areas where water can pool.
- *The grounds were not inspected for roof run-off.

Slope of grade away from structure is inadequate. The grade slopes toward structure. Add fill near the house to slope away approximately 1" per ft. within 6 ft. Keep downspouts extended 5-6 ft. from the house.

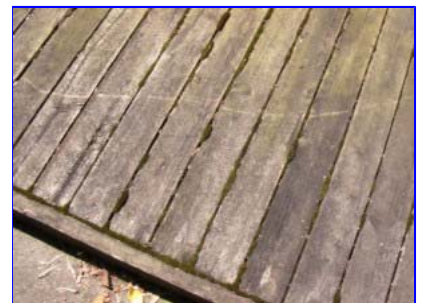
- There is evidence of deterioration where the deck comes in contact with the ground.
- There is evidence of rot on the surfaces of untreated wood.
- There is cracking/deterioration on the deck floor or railings.

- There is separation or sagging due to deterioration.
- There is flashing missing between the deck and the house.

Deck has deteriorated severely due to poor drainage which has caused water damage. Rail system is not securely attached. You should consult a licensed contractor about the needed repairs.

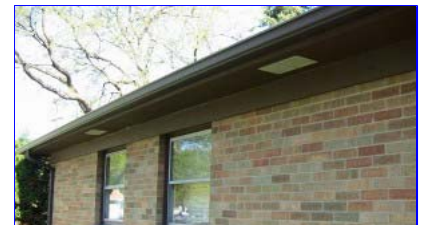
- There are no weep holes in the bottom of brick veneers.

Recommend adding weep holes to the bottom course of bricks to allow possible trapped water to drain out from wall cavity.

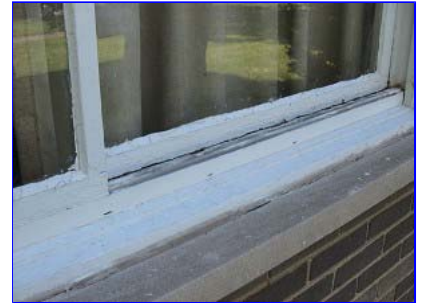
-There are gaps or openings around the window(s) that need to be caulked.
-There are cracked, broken, or missing windows.

This component is in need of minor repair. Windows are not properly caulked. Over time all caulking compounds will deteriorate and require maintenance.

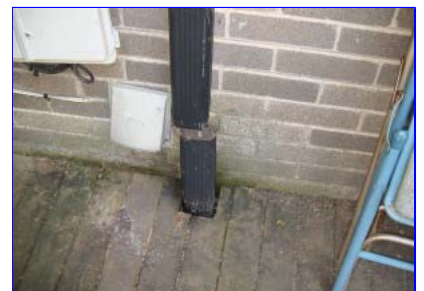
-The downspouts cause water to pool and run toward the house.
-There are spots where downspouts are missing resulting in deterioration to the house.
-There are downspouts missing from the building.

Downspout does not divert water away from foundation properly. There are downspouts that need to be extended. Keep downspouts extended 5' - 6' from the building. Gutters and downspouts need to be added.

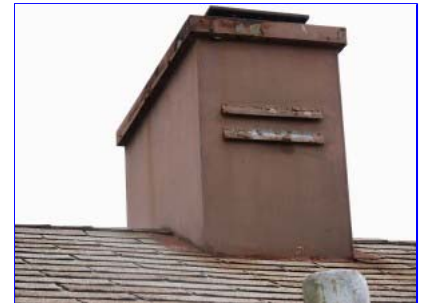
Rusting was observed on chimney cap. Chimney flashing is improperly installed. You should consult a licensed contractor about the needed repairs.

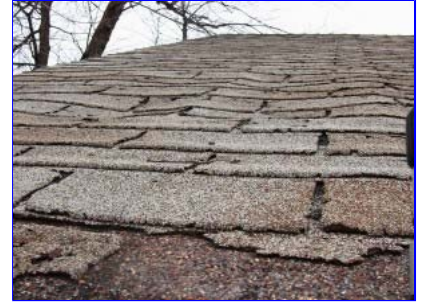
Roof Leaks

- The roof has weather-worn flashing.
- There is discoloration, rot, mold, or mildew on the roof framing.

There are some sunken areas where it is apparent that the shingles have failed and water is penetrating onto the sheathing. In such cases some of the sheathing may need to be replaced when the shingles are replaced. Further water damage could be occurring within the walls or ceilings as the result of water intrusion.

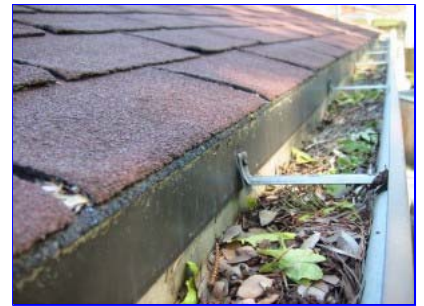
Gutters & Downspouts

- The gutters are clogged with debris from overhanging trees.
- The gutter/downspout connections are bad.
- There are missing sections of gutters/downspouts.

There are down spouts that need to be extended. Downspout does not divert water away from foundation properly. Damage or failure was observed.

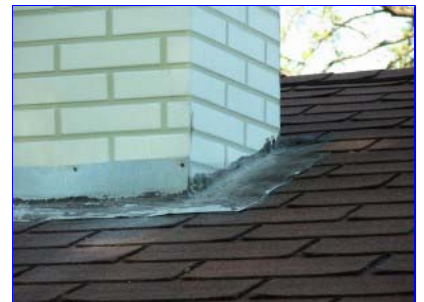
Leaking observed at the chimney flue. Amateur patch job done with roof cement. Flashing at faux chimney cover is flush over shingles and needs replaced.

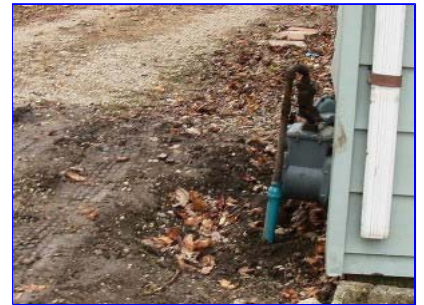
This gas meter is located between the driveway and a path where vehicles can be driven or parked which presents a safety hazard. Recommend protecting this location against any impacts.

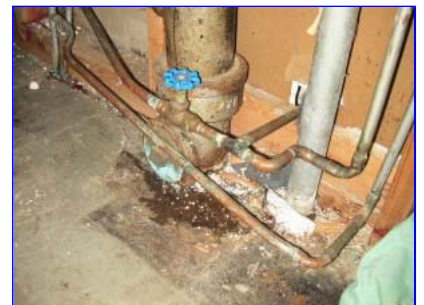
Cast iron part of system appears to have a small amount of seepage at the joint as shown in the photo. Old cast iron pipes rust from the inside out and will eventually need to be replaced.

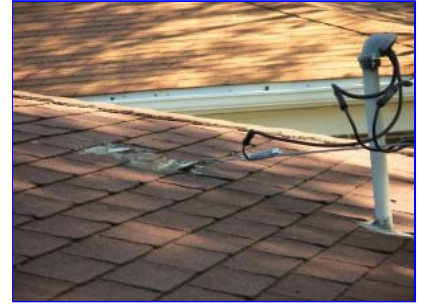
Service Entrance Cable

-The service entrance cable is improperly anchored to the wall.

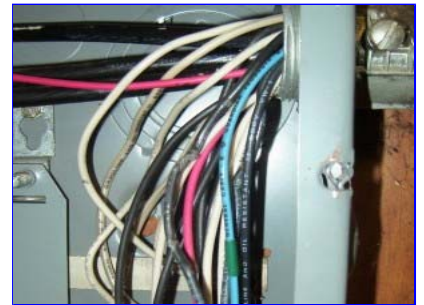
Main Panel

-There is evidence of circuit breakers failing / overloading.

One of the wires shown in the photo has melted insulation which could indicate an over-fused circuit. This could represent a fire hazard and should be examined by an licensed electrician.

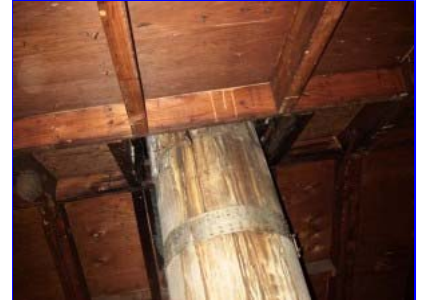
As the photo shows, there are some leaks at flashing points where an exhaust flue goes through the roof. The stains on the flue are indications of this leak.

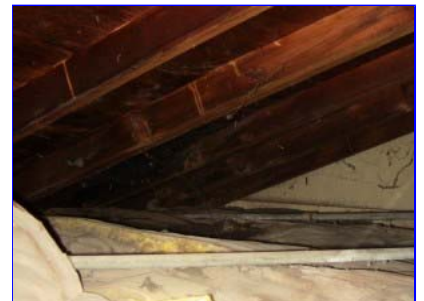
Dark areas indicative of water penetration on SE area of sheathing below area of suspected shingle failure. There were minimal shiners (nails through the sheathing that missed the roof truss framing.)

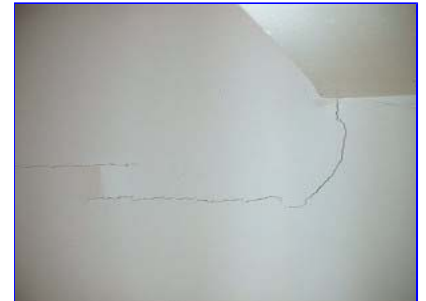
The photo illustrates a crack in the kitchen wall near the ceiling which could indicate uneven settlement in one area of the house.

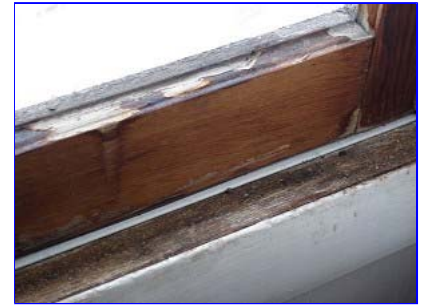
- The windows insulate poorly.
- There are windows stuck or painted shut.
- There are bedrooms without properly functioning egress windows.

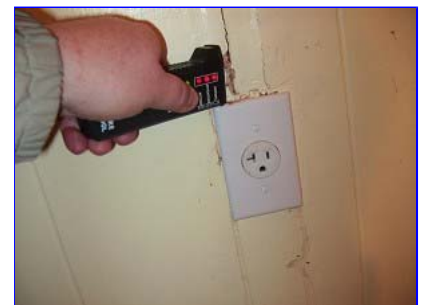
Photo shows the wall next to 240-volt outlet testing high for moisture. It appears that a roof leak is draining down the wall in the laundry room.

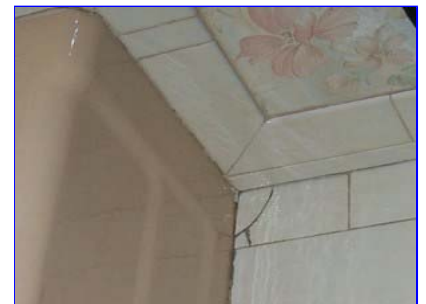
Tile is cracked near tub and needs re-grouted. Flexible caulking needs applied wherever tile meets an edge.

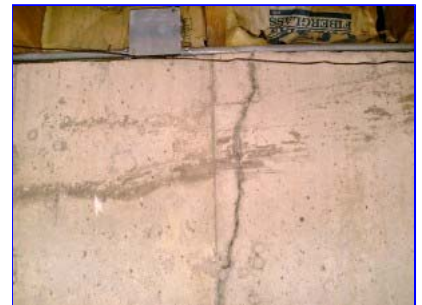
Not all areas of the foundation were visible at the time of the inspection. The foundation appears to be performing from what can be observed. There are several thin cracks visible in the foundation less than a quarter inch wide which are typical of an older masonry foundation.

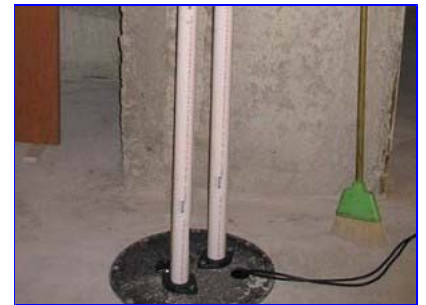
The sewage ejector pump was unplugged and may not function properly. The sewage ejector pump moves waste from basement plumbing fixtures (i.e. toilets, showers, etc) to the level of the sewer line

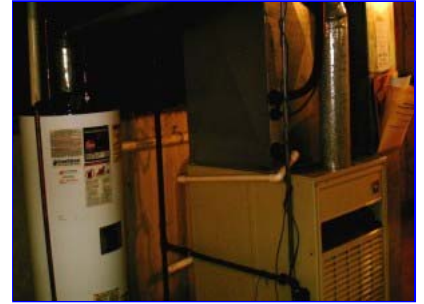
Furnace is over 20 years old and only 70 percent efficient. It is nearing the end of its useful life. Consider budgeting for a high efficiency furnace.

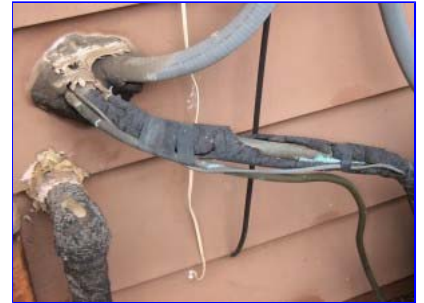
- There are obstructions blocking a free air exchange.
- The refrigerant tubes are poorly insulated.

Model GE LMB-48AK10 (4-tons). The unit appears the right size for a 2,000 sq. ft. home and produces cold air when tested. The insulation on the return line is missing, damaged, or defective decreasing efficiency. Clean leaves and debris away from outdoor condenser coil.
