PHII Inspections

Lab Inspection
ID: United States
1533 NW 2nd St.
Madison, SD 57042

123 any st
madison SD 57042

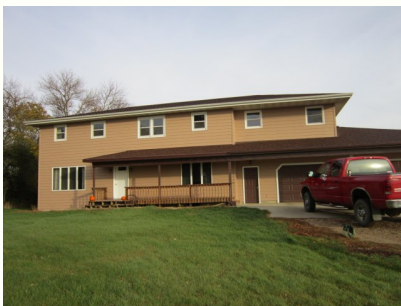
Driveway has some age but is still serviceable.

Driveway has very minor cracks typical for the age of the driveway.

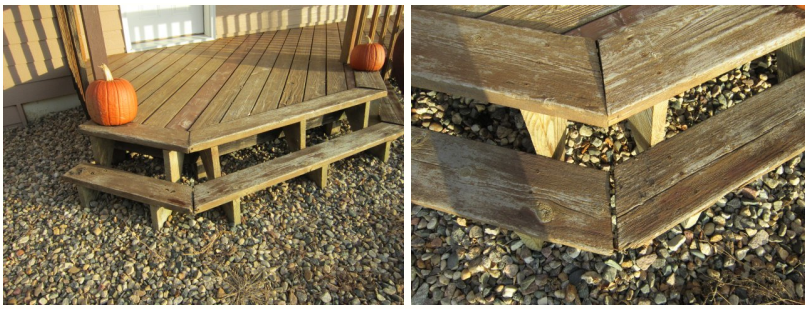
Steps to Building

- The steps are deteriorating.

Slight need for maintenance with front steps. No serious problems though.

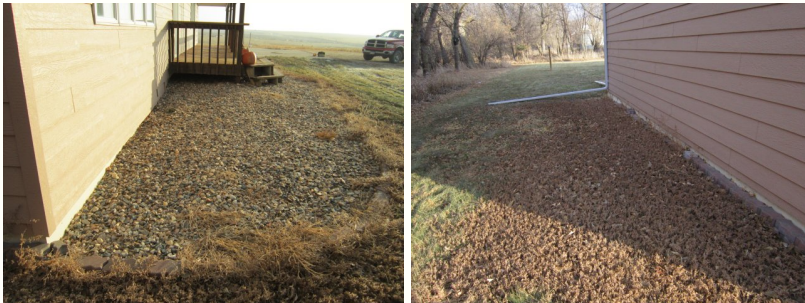
Grading at House Wall

- The ground slopes toward the house.
- There are low areas where water could pool.

Negative slope to the house from front yard. Some low areas around the house wall where water can pool on West side of the house. Consider adding fill near house wall to improve slope / drainage conditions.

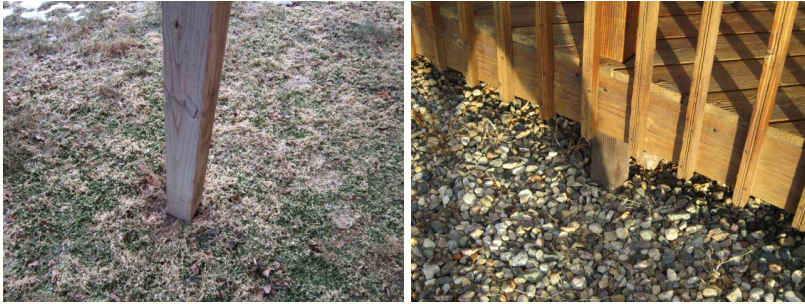
Deck

·There are signs of deterioration where the deck touches the ground.

Recommend treatment of the deck to extend life of the deck. No cement footings under pillars. Wood posts are in contact with the ground but no deterioration was observed. Uneven steps or risers present a trip hazard. The handrails are not the correct height.

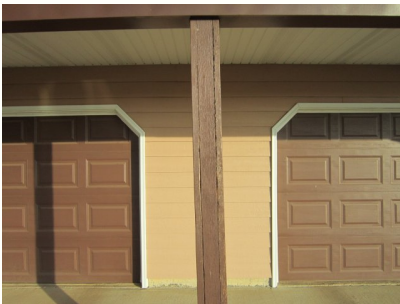
- There are signs of deterioration to the columns.

Columns under front roof structure is not plumb and needs maintenance/

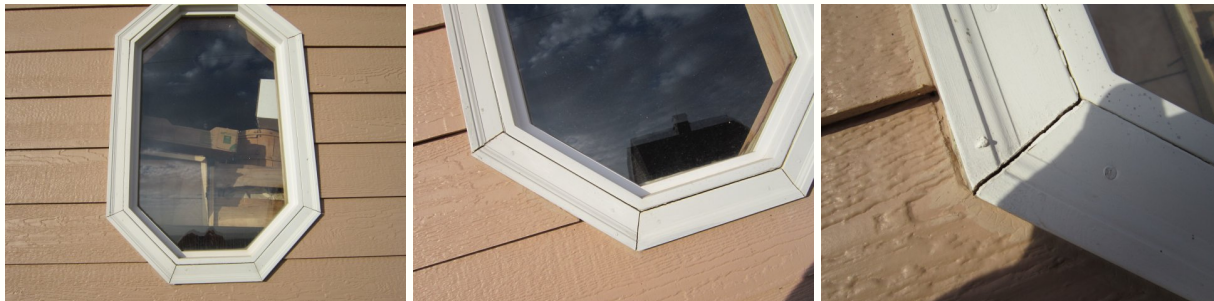
Trim

·The caulking is shrinking / pulling loose.

Caulking is missing around moldings at the windows on the east side of garage.

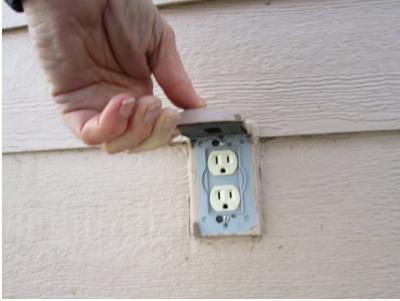
Exterior Receptacles

- There are exterior receptacles without GFCI circuits.

Left rear receptacle is non-GFI and an open groundfault;balcony recep. is not GFI, and not energized.Recommend that a licensed electrician check outside electrical and upgrade to GFCI protection for your own safety.

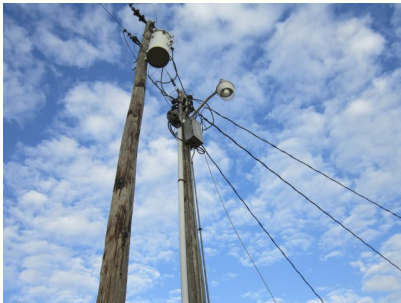
Service Line Entrance

Main panel treated as a sub-panel due to the primary service entry and meter being on the large light pole to the left rear of the house. The primary shut-off is located there as well.

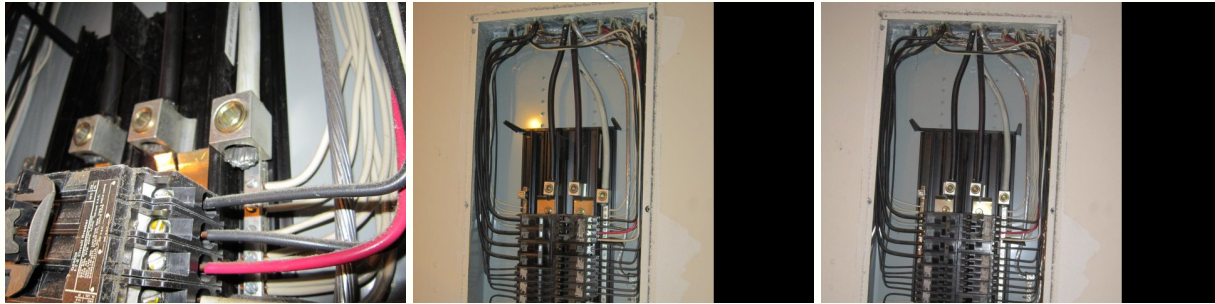
Main Panel

Main panel is treated as a sub-panel due to the primary service shut off and meter as well as grounding being located at the service meter and primary shut off pole to the right rear of the yard.

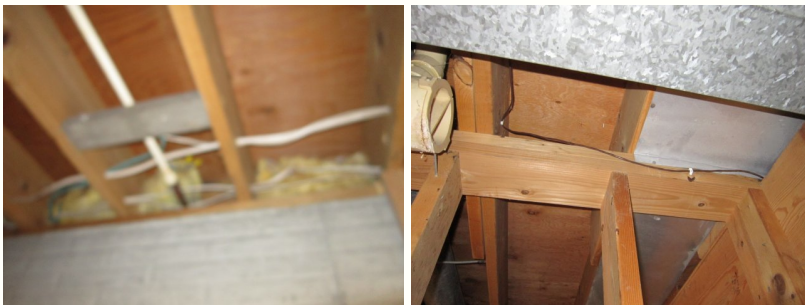
Circuits & Conductors

- There are improperly wired GFCI circuits.
- There are improperly spliced wires.

Two bathrooms (lower) and one of the kitchen outlets are GFI. One outlet to the right of the sink within 6 feet is non-GFI. There are also outlets upstairs near water that are not GFI. Non of the outlets in the garage were GFI, and one had a missing ground. All outlets at the garage work bench are open ground. Recommend upgrading to GFI outlets in these areas for your safety. All receptacles are not grounded. Splices in electrical wiring are outside of junction boxes.

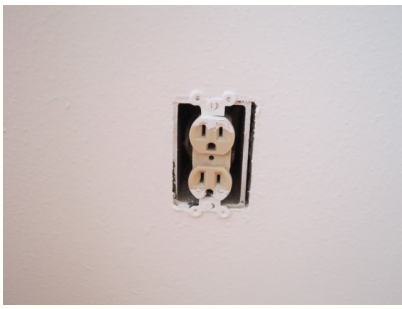
Outlets, Fixtures, & Switches

- Reverse polarity
- Non-GFCI
- Ungrounded

- There are missing / broken faceplates.

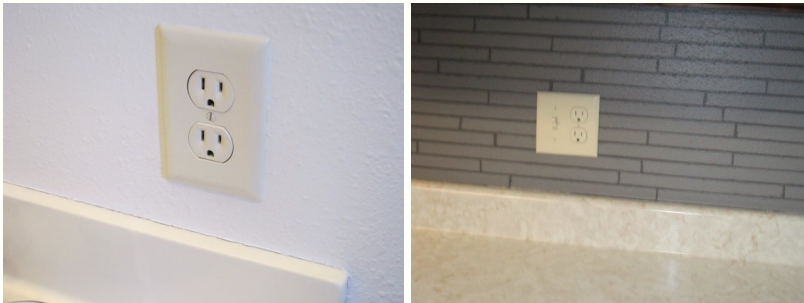
Receptacles

- There are non-GFCI receptacles in the kitchen.

the receptacle to the right of the sink is non-GFCI.
Recommend upgrade to GFCI for safety reasons and compliance to outlets within 6 feet of water outlet.
