PHII Inspections

Lab Inspection
ID: United States
1533 NW 2nd St.
Madison, SD 57042

123 any st
madison SD 57042

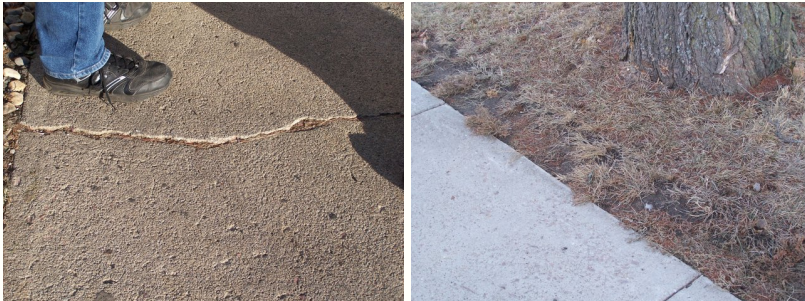
Sidewalks / Walkways

- There is evidence of spalling.
- There are uneven spots on the sidewalk.
- There are tree roots growing too close to the sidewalk.

There is some spalling visible on the sidewalk. Tree roots are growing too close to the sidewalk in the front. Some spalling on other sidewalk was typical for the age of the house. Sidewalk shows some spalling typical with the age of the house.

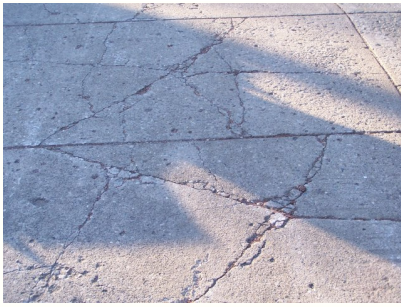
- The driveway is showing evidence of spalling.
- There are large cracks in the driveway.

Driveway has very minor cracks typical for the age of the driveway. Driveway shows some cracking - Not unusual. Deterioration of the driveway surface was observed. There are major cracks in the driveway surface. The driveway shows extensive spalling - Still serviceable.

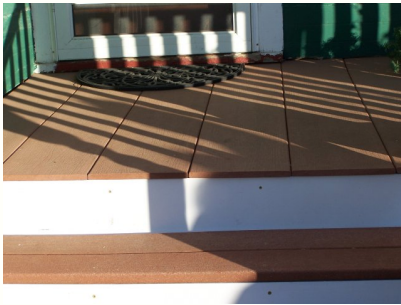
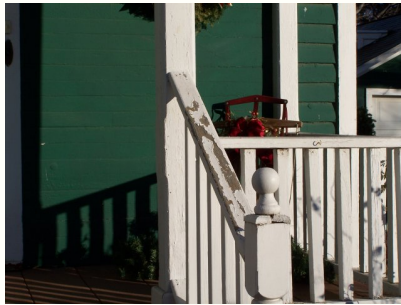
Steps to Building

One of the top steps is loose and needs to be secured.
Slight need for maintenance with front steps. Steps were a composite material and loose on the front porch. No railing on the stairs to the breezeway.

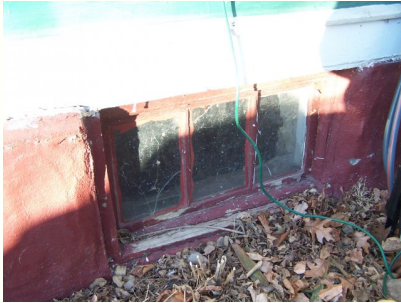
Grading at House Wall

The basement window on the west side is too close to the ground. Recommend check with contractor to install a window well.

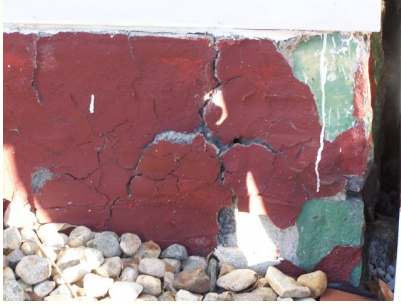
Foundation

Shows signs of separation of applied skim coat to foundation exterior. Masonry covering on exterior foundation is cracked and pulling away.

- There are gaps in the mortar.

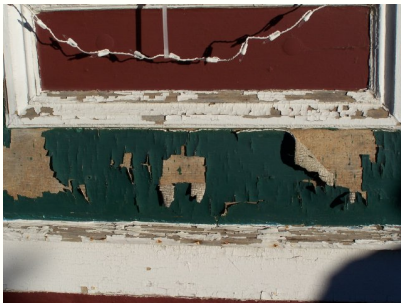
Exterior Wall Covering

- Paint is peeling off of the siding material.

could be lead base paint on the age of the house
Recommend painting. Painted shakes.

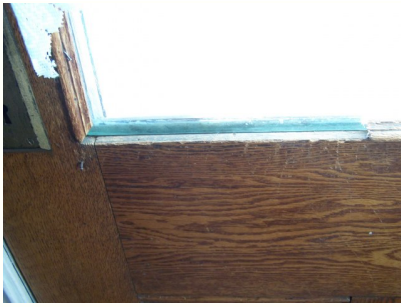
Exterior Doors

Chalking missing/shrinkage around door's window seal.

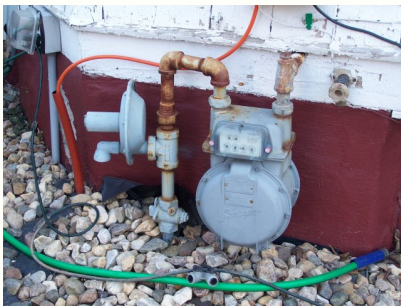
Gas Meter / Piping

- The pipes are rusted.

Visible rust on gas piping entering the home.

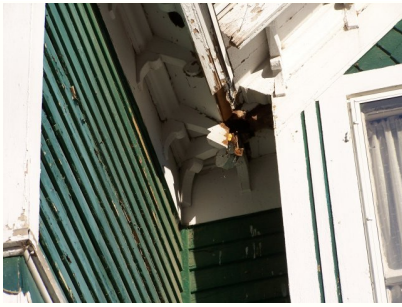
Eaves & Soffits

needs painting most of the house does not have gutters. The soffit and fascia above front entry is deteriorated and rotted and animals may enter the attic

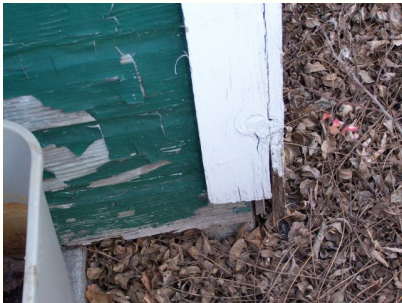
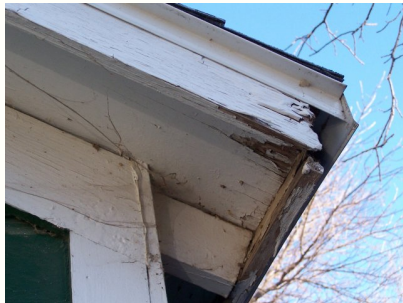
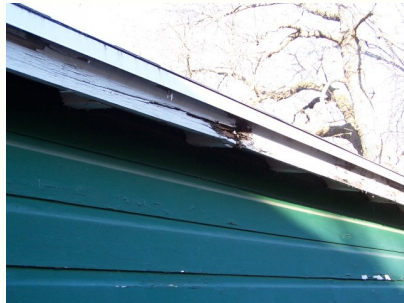
Trim

Some paint is peeling and needs to be repainted. Window trim needed painting or wrapped in metal. garage fascia board has a deteriorated board Corner boards are damaged or deteriorated.

- There are signs of rot on the trim.

Some paint is peeling and needs to be repainted.
Window trim needed painting or wrapped in metal.
garage fascia board has a deteriorated board
Corner boards are damaged or deteriorated.

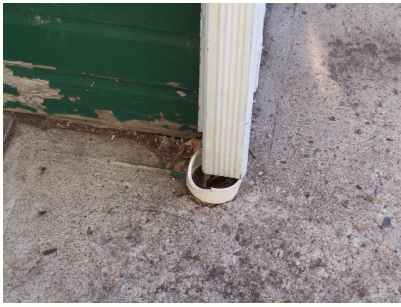
Downspouts

Underground drainage appears to be plugged at garage.

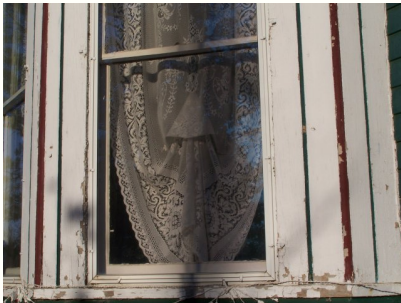
Exterior Windows

- There are gaps or openings around windows that are uncaulked.
- There are windows that have been painted shut or no longer function.

Windows need caulking and re-paint. Windows showing signs of weather. Many windows are painted shut (permanently). Glazing compound is deteriorated.

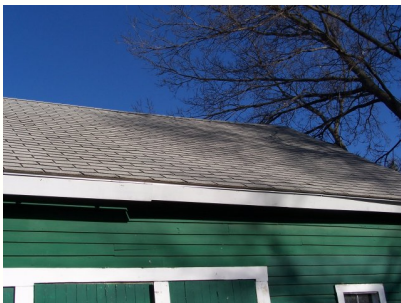
Roof Covering

Roofing on old barn out building appears to be nearing end of useful service.

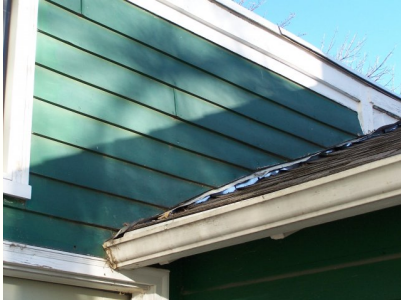
Exposed Flashing

- There is flashing that has been improperly installed.

Flashing needs to be added/repaired.

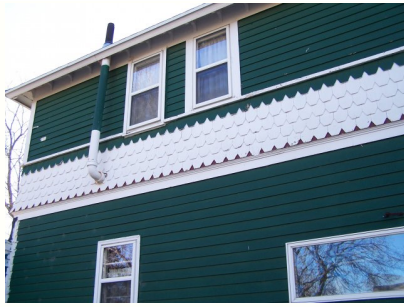
Vent Pipes

Vent pipe penetrates through outside wall at back home house, may cause frost exposure.

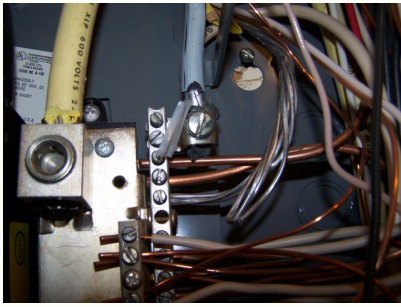
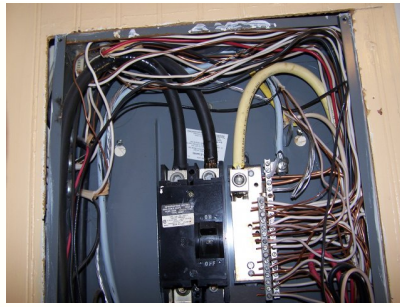
Main Panel

Neutral to sub-panel has strands cut to insert into connector.

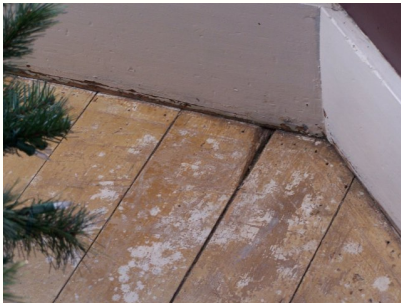
Floors

Refinish wood flooring. Most of the flooring is wood flooring and needs to be sanded and refinished

Refinish wood flooring. Most of the flooring is wood flooring and needs to sanded and refinished

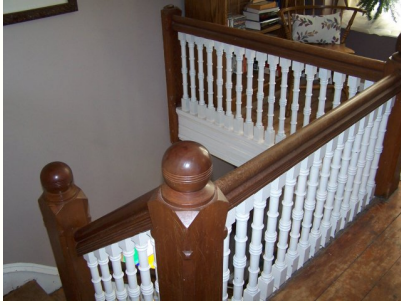
Stairs / Railings

Handrails were proper height, but the railing on upper level by exercise equipment is too low.

- The handrails are too short (less than 34").

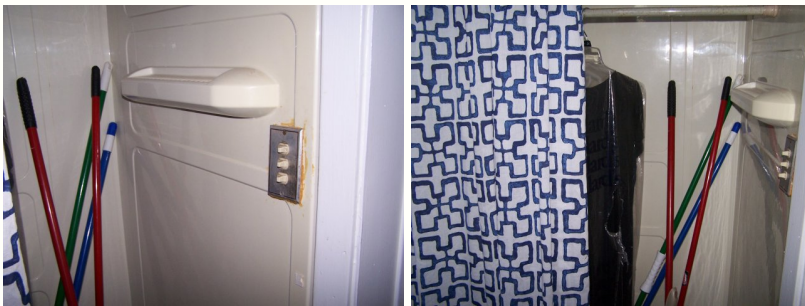
Location

Electrical switches in shower area should be moved.

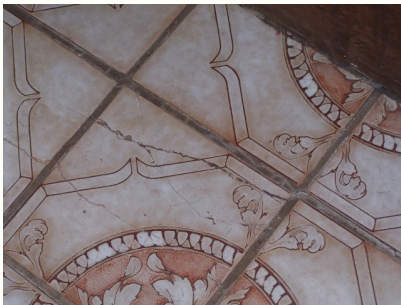
Flooring

.Some tile are loose and grout is cracked

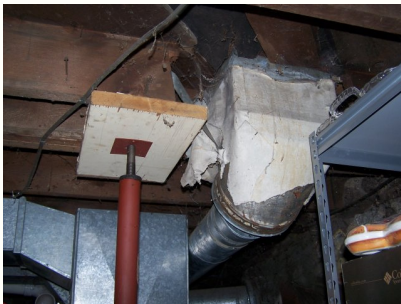
Columns are not properly anchored at base top.

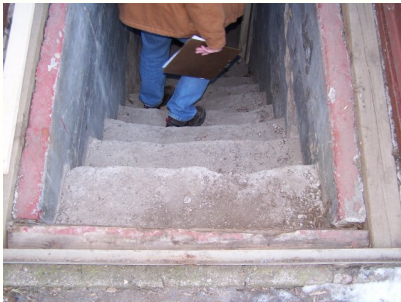
Stairs / Railings

- Stairs are too steep (more than 8"/9").
- The stairs are missing a railing.

Low head clearance. Stairs should have a railing.

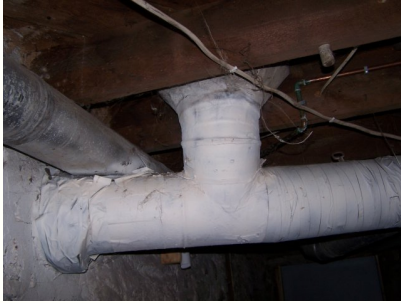
Heat Distribution

Some of the ductwork is covered with white cloth material which could be asbestos, which normally not a hazard if not disturbed.

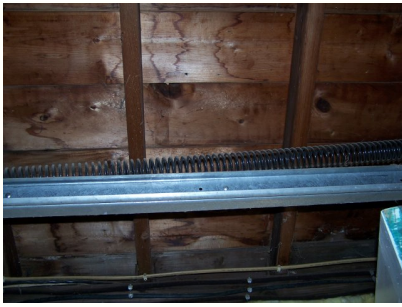
Vehicle Doors

·The safety cables are missing from the lift springs.
